Structural Evaluation Report

October 3, 2007

Re: Needham Town Hall Study
Preliminary Structural Condition Assessment

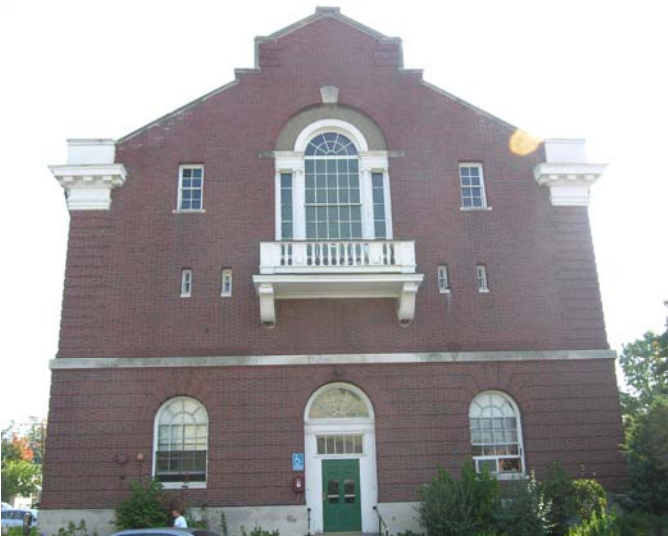
1. West elevation Town Hall.
Photographs two through twelve
are taken from this wall.

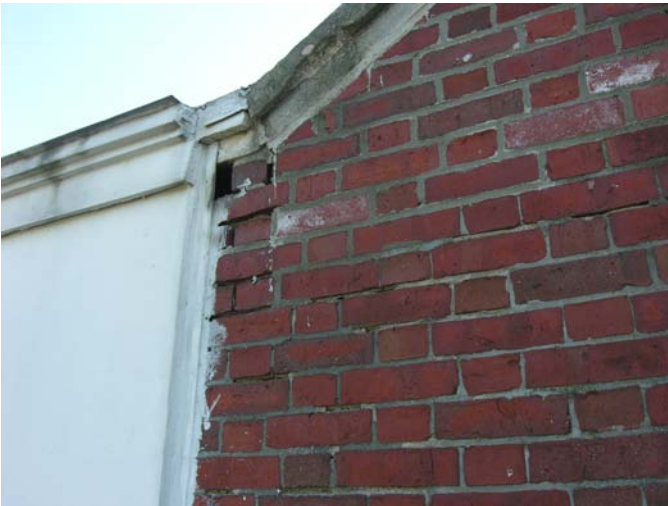
- b. Coping units do not appear to have flashing between the units and the brick. The coping stones are now sealed with elastomeric type caulking and tied together with face mounted cramps. Some sketches of what appears original construction indicate the vertical steps in the parapet now faced with vertical coping once held larger stones. This may have been the case also at the kneelers which traditionally held large stones to lock the sloped coping in place. These are now brick covered by metal.

2. Metal kneeler cover by roof
eave above cornice. Near top,
brick is set back about four
inches behind metal cover. In
traditional masonry, this kneeler
would have been a stone unit.

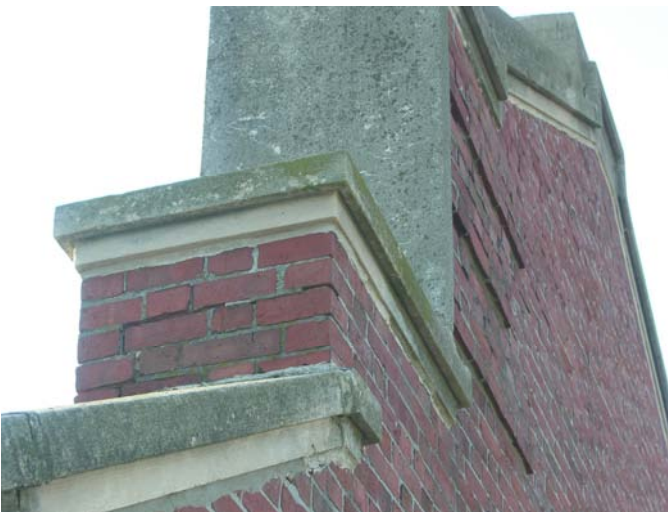
3. Step in coping at near top of
wall. Brick facing joints are
cracking on edge of wall.
Vertical coping is not a standard
use in traditional masonry.

- c. Reset all the coping stones with flashing in the bed joints. Restore missing coping stones.
 - d. Repoint and add lead T-caps to belt head joints.

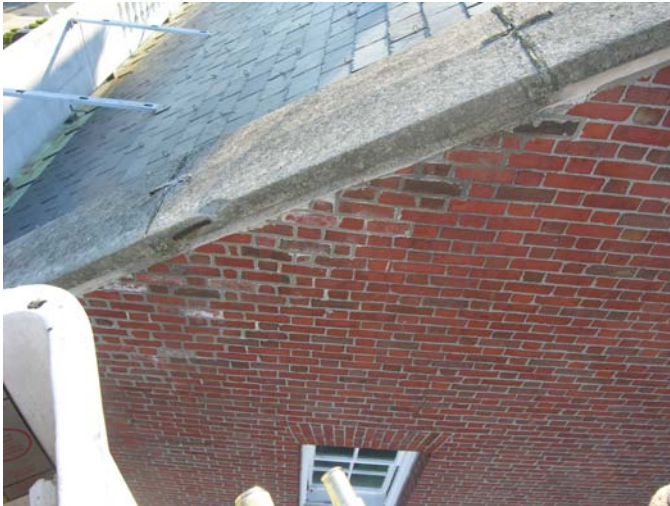
4. Coping head joints tied together with metal cramps covered with asphalt shingles.

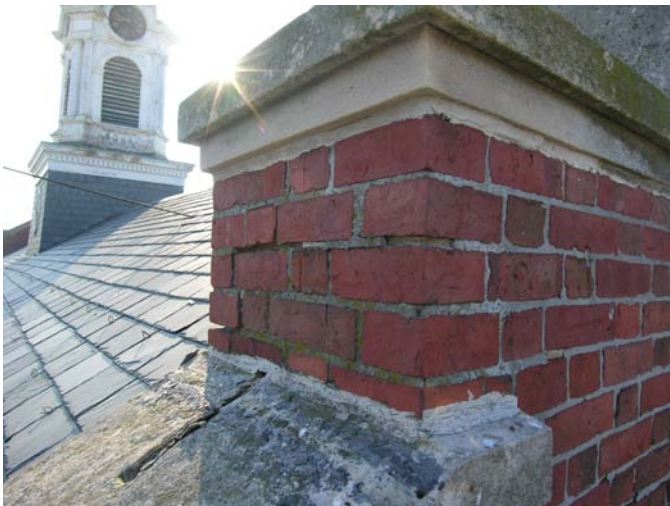
5. Cracked mortar joints in brick edge of wall. Stone coping bed joints covered with elastic sealants.

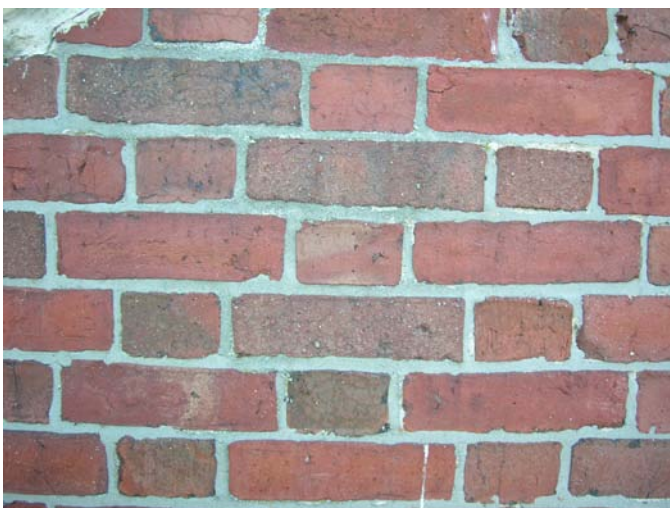
6. Masonry joints covered with thin veneer of gray mortar.

- b. The gray overlay mortar poses a problem of deciding to live with it or restore the joints to their original buff color and texture. The latter option requires cutting and repointing all the joints. The side walls do not need much repointing. The end walls need repointing where rebuilding is carried out. To get consistency in color, the choice is complete repointing with the original buff color or less repointing with the subsequent gray.

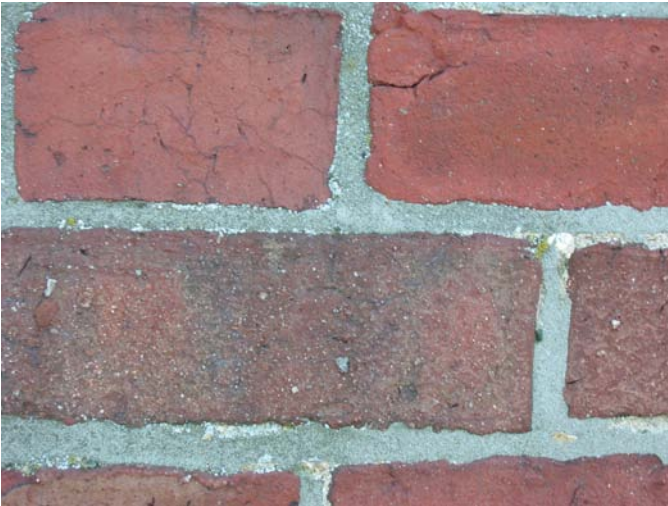
7. Close up view of thin overlay of mortar in joints. This gray mortar conceals a buff colored mortar.

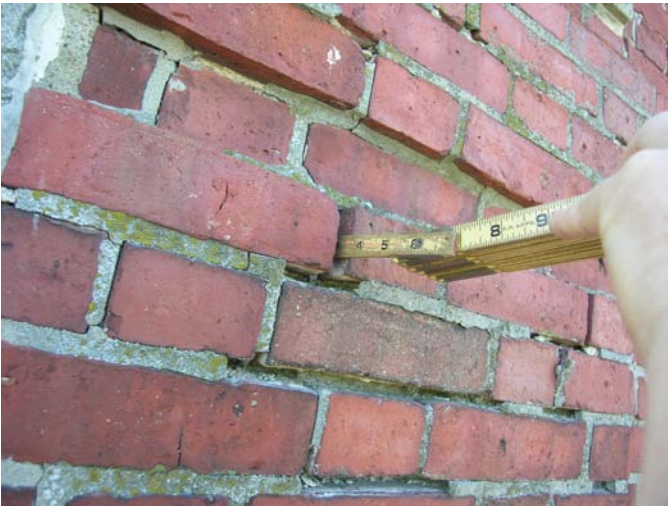
8. Some joints are missing mortar one brick deep.

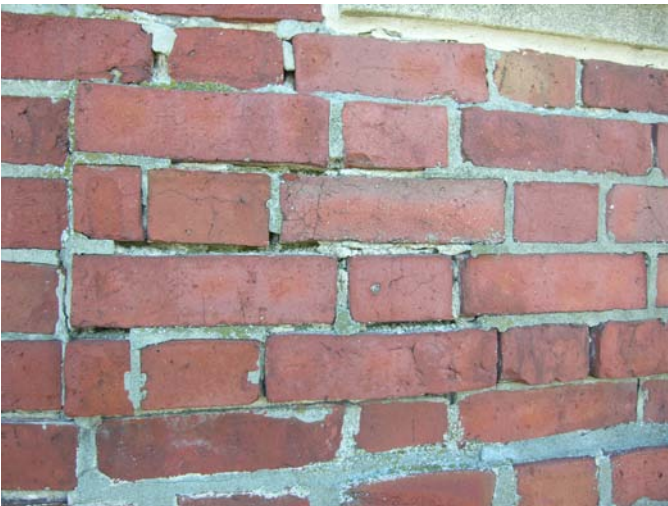
1. West and east end walls.
 - a. Along the roof line, exterior mortar joints are breaking down. The fractured mortar is a result of moisture drawn into the walls and freezing. As the water turns to ice, it expands and fractures mortar. Masonry at the roof line undergoes a greater range of temperature changes where little heat reaches the masonry in freezing weather. The effects of the environment are compounded by the use of common brick as backup for face brick and the use of mortar mixes not formulated for extreme conditions. The problem is more extensive on the east wall.

9. Common condition of mortar joints in wall at roof line

2. Long term masonry repairs.
 - a. Rebuild masonry in the end walls susceptible to freezing. Use brick throughout the thickness of the wall that is rated for severe weather. Rebuild with mortar that is freeze resistant.

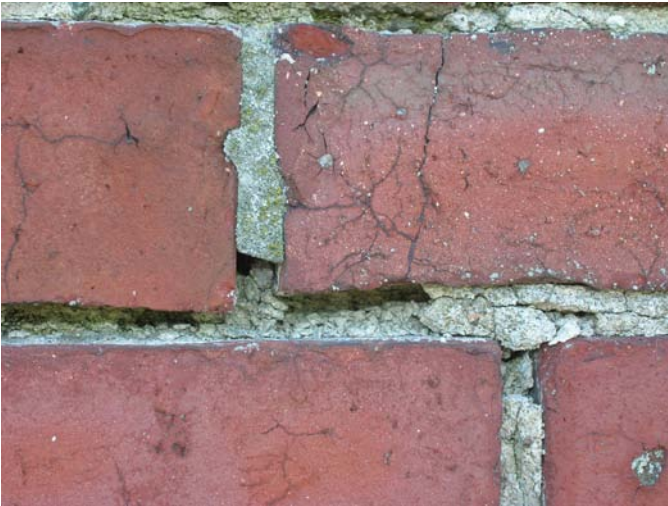
10. Closer view of broken mortar joints. Note mortar within joints is broken in layers. This is commonly seen in brick walls that are subjected to freezing.

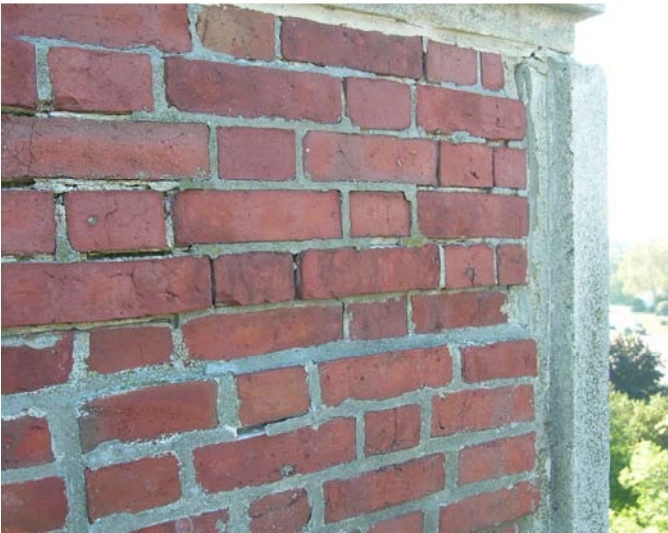
11. Broken joints near large step in coping.

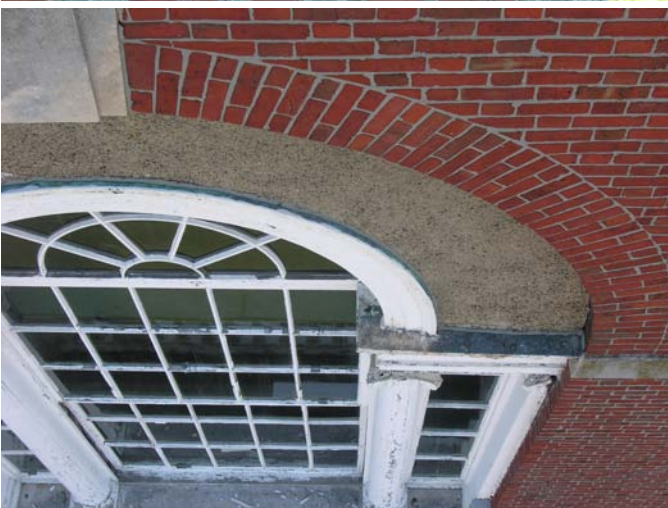
12. View of wall over top of large window. A radial band of stucco conceals the ceiling line.

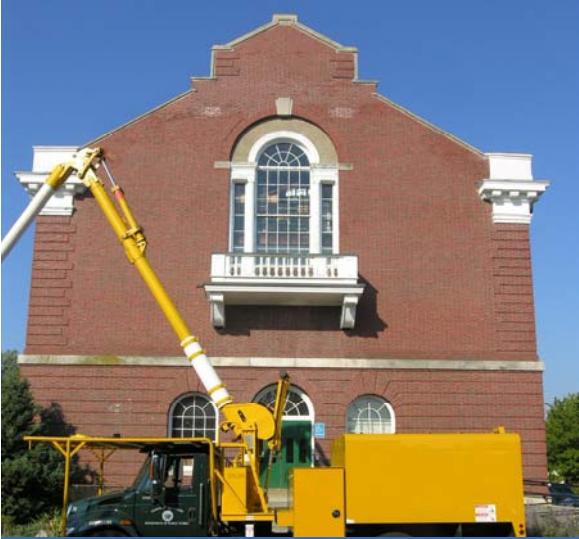
13. East elevation Town Hall. Photographs fourteen through eighteen and twenty-one are taken from this wall.

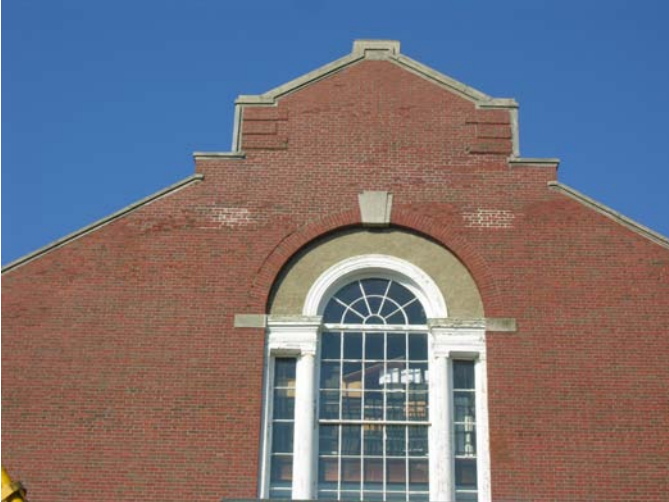
14. Wall over window appears repaired at a time different than when wall was repointed with an overlay of mortar. Two white patches are from an investigation several years ago. Mortar is missing above brick arch on south half of window.

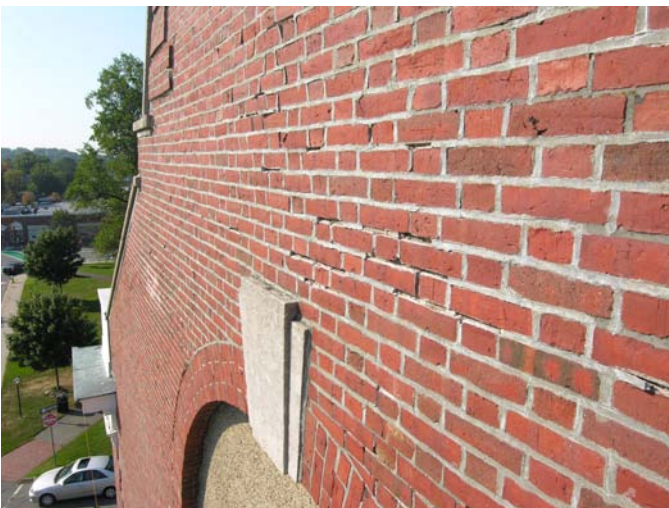
15. Close up view of wall over window showing broken mortar joints.

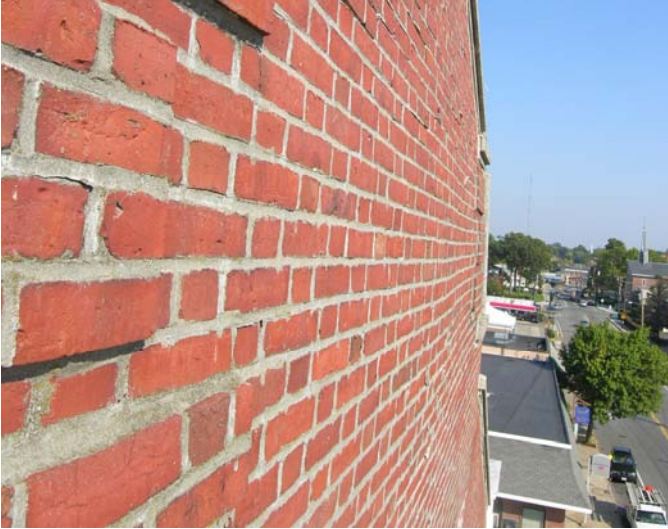
- b. A vertical bulge lies over the top of the large window. It developed for the same reasons as the one in item 2.a.
 - c. Freeze action is eroding the interior face of the wall within the attic.

16. Vertical bulge in wall over window.

1. Urgent masonry repairs. Stabilize the bulges in the east wall by either rebuilding facing and broken backup brick at the bulges or by adding temporary interior and exterior bracing to constrain the bulges.

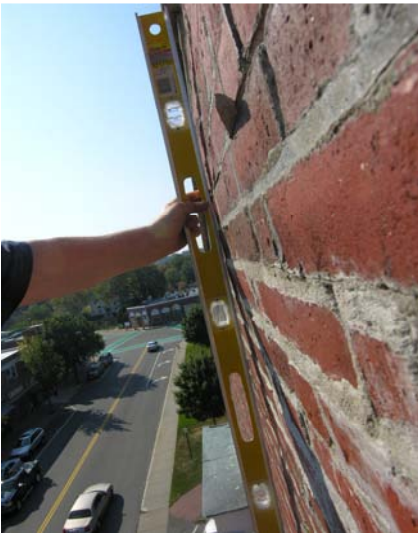
- c. Mortar in belt course head joints is falling out.
2. East end wall.
 - a. A horizontal bulge lies between the south wall and the large window at the level of the ceiling. This bulge is a result of water trapped in the backup portions of the wall freezing and turning to ice. This process fractures the softer backup brick and pushes the face brick outward.

17. Horizontal bulge in wall south of window. One can scale the extent of the curvature knowing the level is two and one half inches wide and scaling the distance between the edge of the level and its shadow.

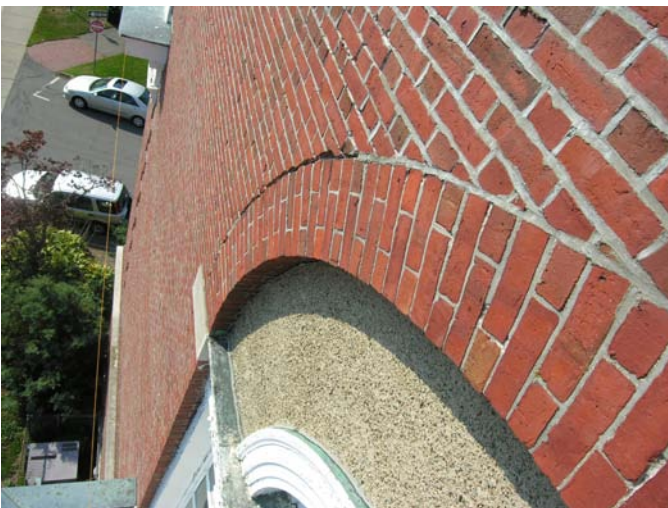
18. Mortar missing from window arch. Several points on this wall were measured for plumb by holding a plumb bob to the orange mason line shown in the background.

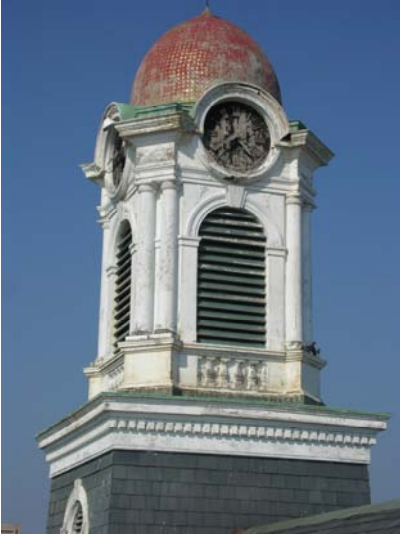
4. Cupola. From the exterior, the cupola appears stable and in its original position. From the inside, the discoloration of the deck underside is suspect for mold or fungi deterioration. The hazardous environment prevented a closer inspection.

19. The cupola as seen from the east end of the building.

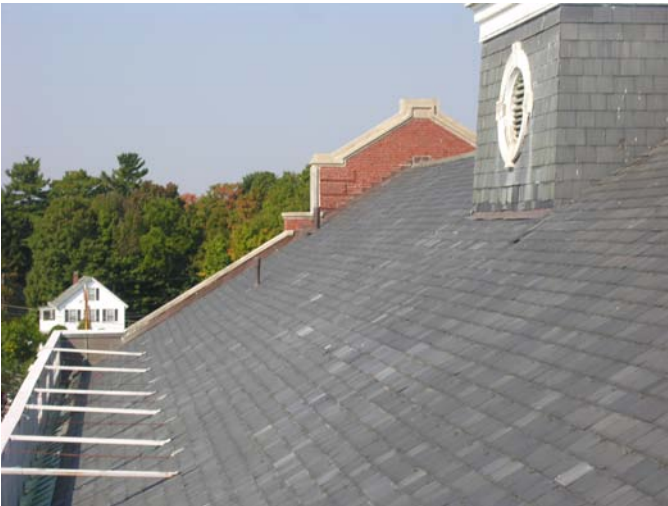
20. Roof as seen from the west end of the building. Balustrades have added bracing to supplement tie rods. Brick on the concealed side of the parapets have the same detailing as that on the exposed side.

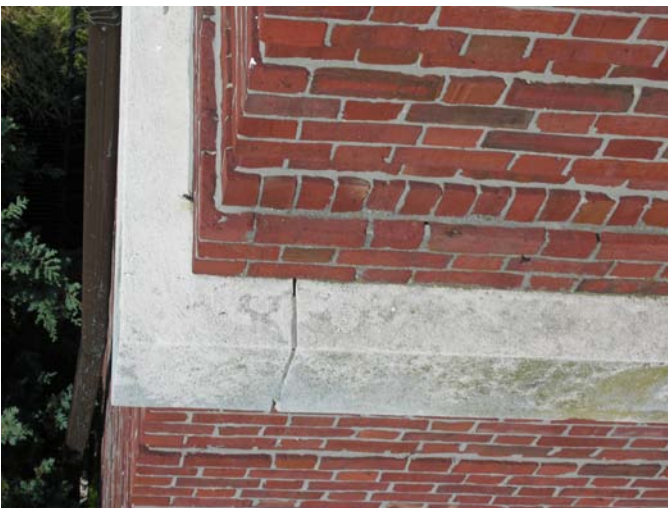
21. Mortar missing from head joints in stone belt.

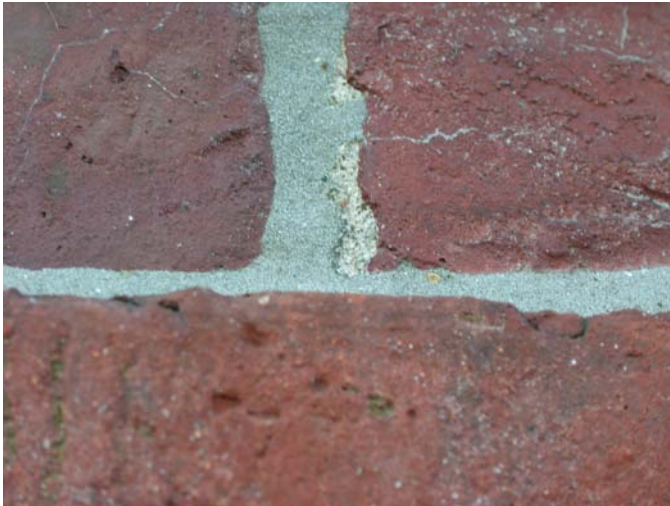
22. Close up view of mortar overlaid on original buff colored mortar.

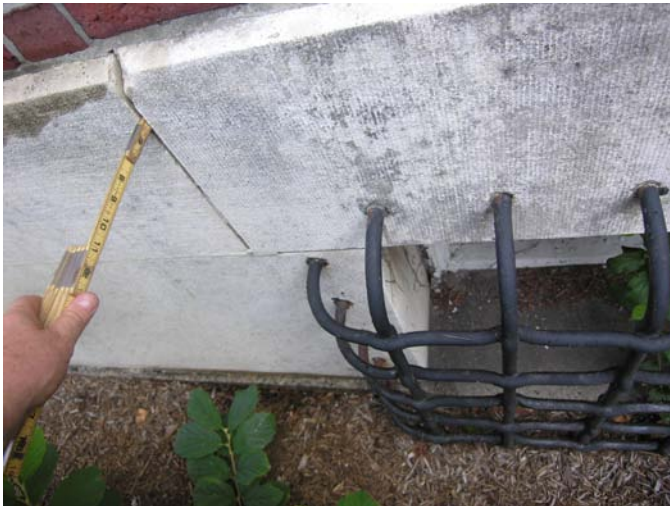
23. Mortar missing from head joints in stone facing at base of building.

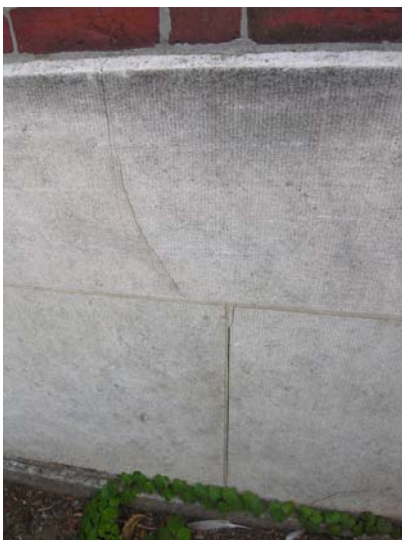
24. Cracked unit and missing mortar from stone at base of building.

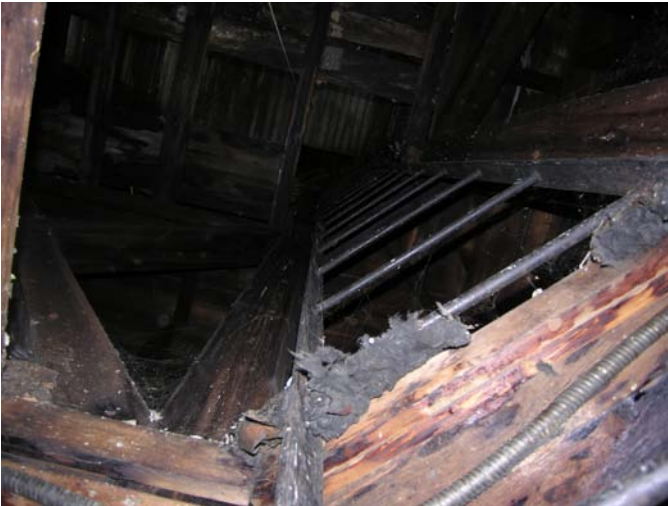
25. Cupola viewed from attic. This writer did not enter this area as cupola is actively occupied by pigeons, which are well known to soil their roost with guano and fungi hazardous to humans. The whitish stains on the underside of the cupola deck may indicate deterioration in that wood.

3. Cupola assessment.
 - a. Employ a hazardous waste removal contractor to clean the cupola.
 - b. Apply a bird and insect screen to the cupola.
 - c. Carry out a structural survey in the cupola.
4. Roof truss assessment.
 - a. Find records to explain why gussets were added to the trusses.
 - b. Or, measure the trusses, carry out a stress analysis, and carry out an inspection of the joints by selectively removing several plates at disparate joints. One of the joints should be at the truss heel. This will require trade assistance to provide access, temporary shores, and plate removal and reinstallation.

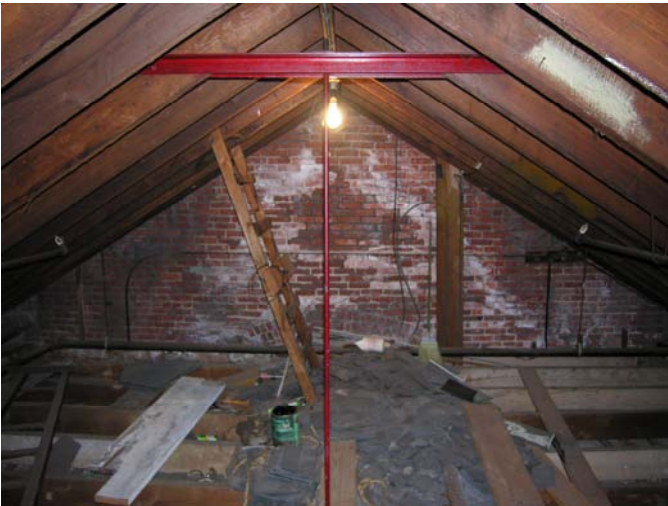
26. East wall gable viewed from within the attic.

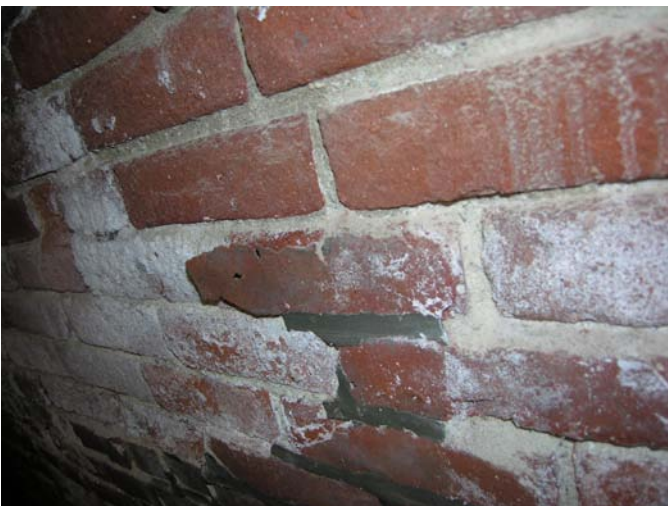
27. Close view of east wall in attic. Mortar is eroding from frost action. Faces of brick are scaling off bodies of units.

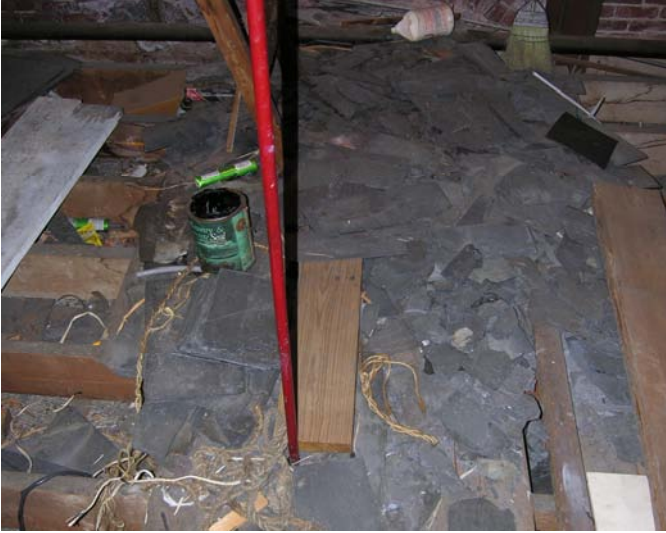
28. Left over slate shingles add unnecessary weight to ceiling joists.

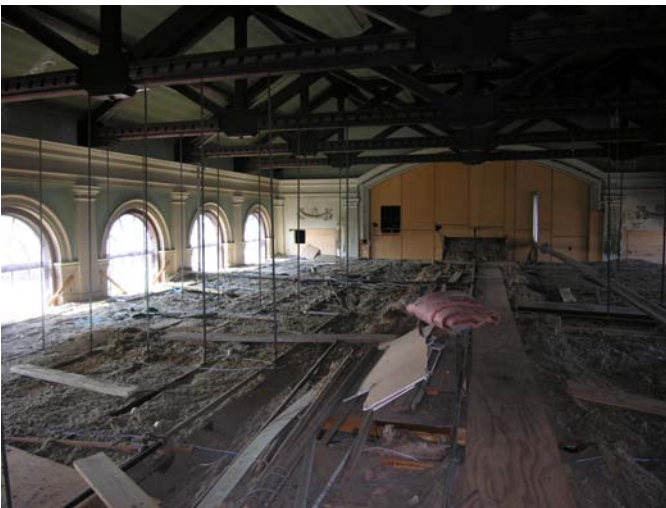
29. Suspended ceiling over second floor added in the mid 1900's. The center is supported on corridor walls. The areas supported by hangers are not work platforms. Planks in these areas indicate trade mechanics have used this ceiling as a work platform.

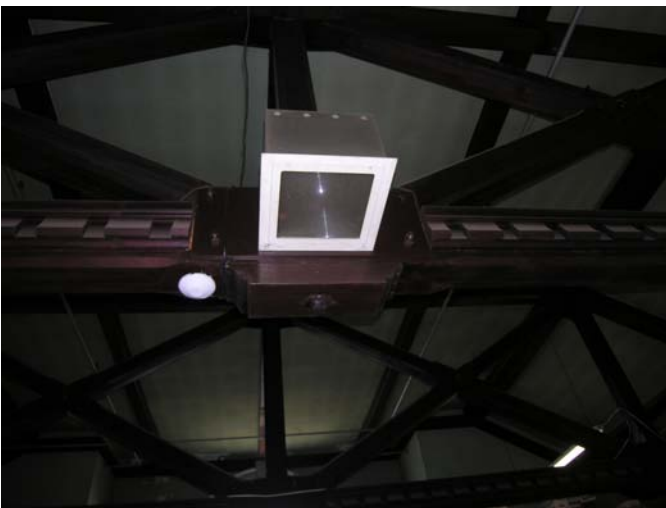
5. Roof trusses. The roof trusses appear reasonably proportioned. From experience, this writer does not find roofs that are overdesigned. Most are designed for a snow load and no more. The addition of steel gusset plates should raise the question, why were they added? They do not appear designed by an engineer familiar with timber truss design. The bolts are too few and too small to adequately transfer forces for trusses of this size. These gussets conceal the original joinery preventing a visual inspection of the joints.

30. Light fixtures are supported on steel gusset plates. This suggests the lights illuminated the former hall after the gussets were installed. Such gussets were not used during the period of original construction.

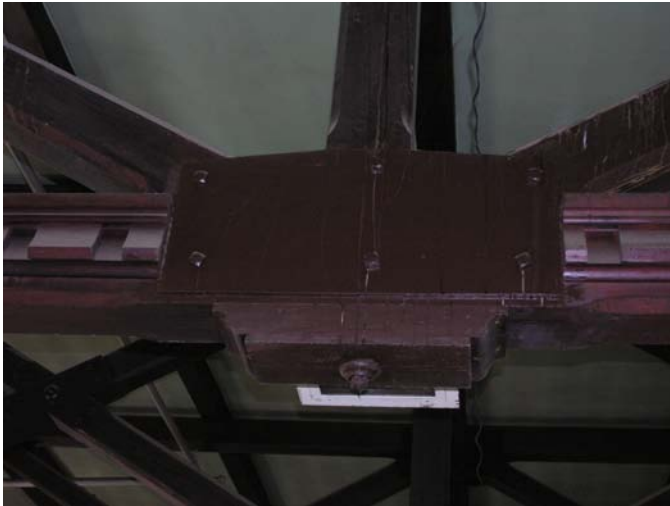
31. Closer view of a gusset. The wood dentil molding was cut away to make space for the gussets. The bolts are too few and too small to adequately carry forces for timbers of this size. These were added after original construction but the reason why is not apparent.

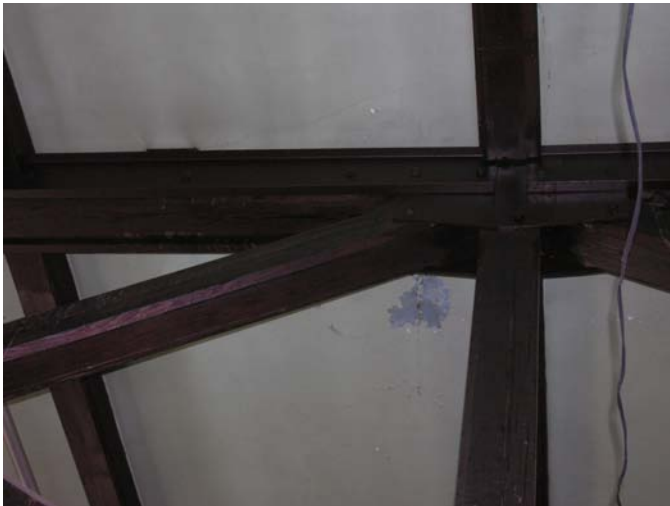
32. Steel channels were added to the top chords of the two trusses under the cupola. The cupola posts can be seen penetrating through the ceiling.

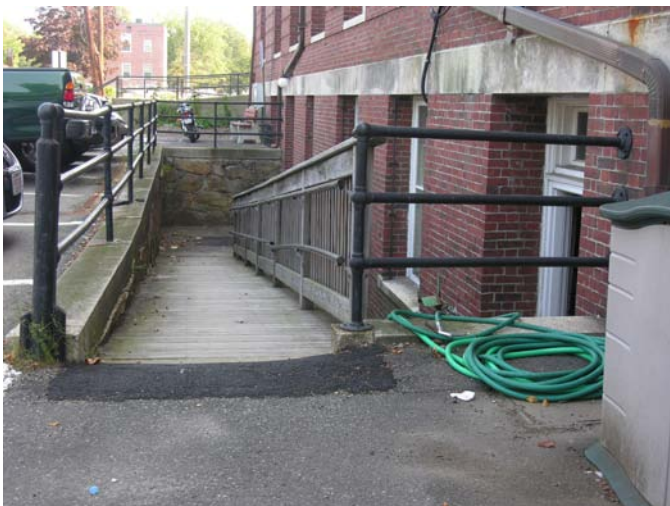
6. Service ramp. The retaining wall at the service ramp areaway is leaning inward. It appears undersized at resisting lateral earth pressures.

33. The retaining wall along the service ramp is dislocated.

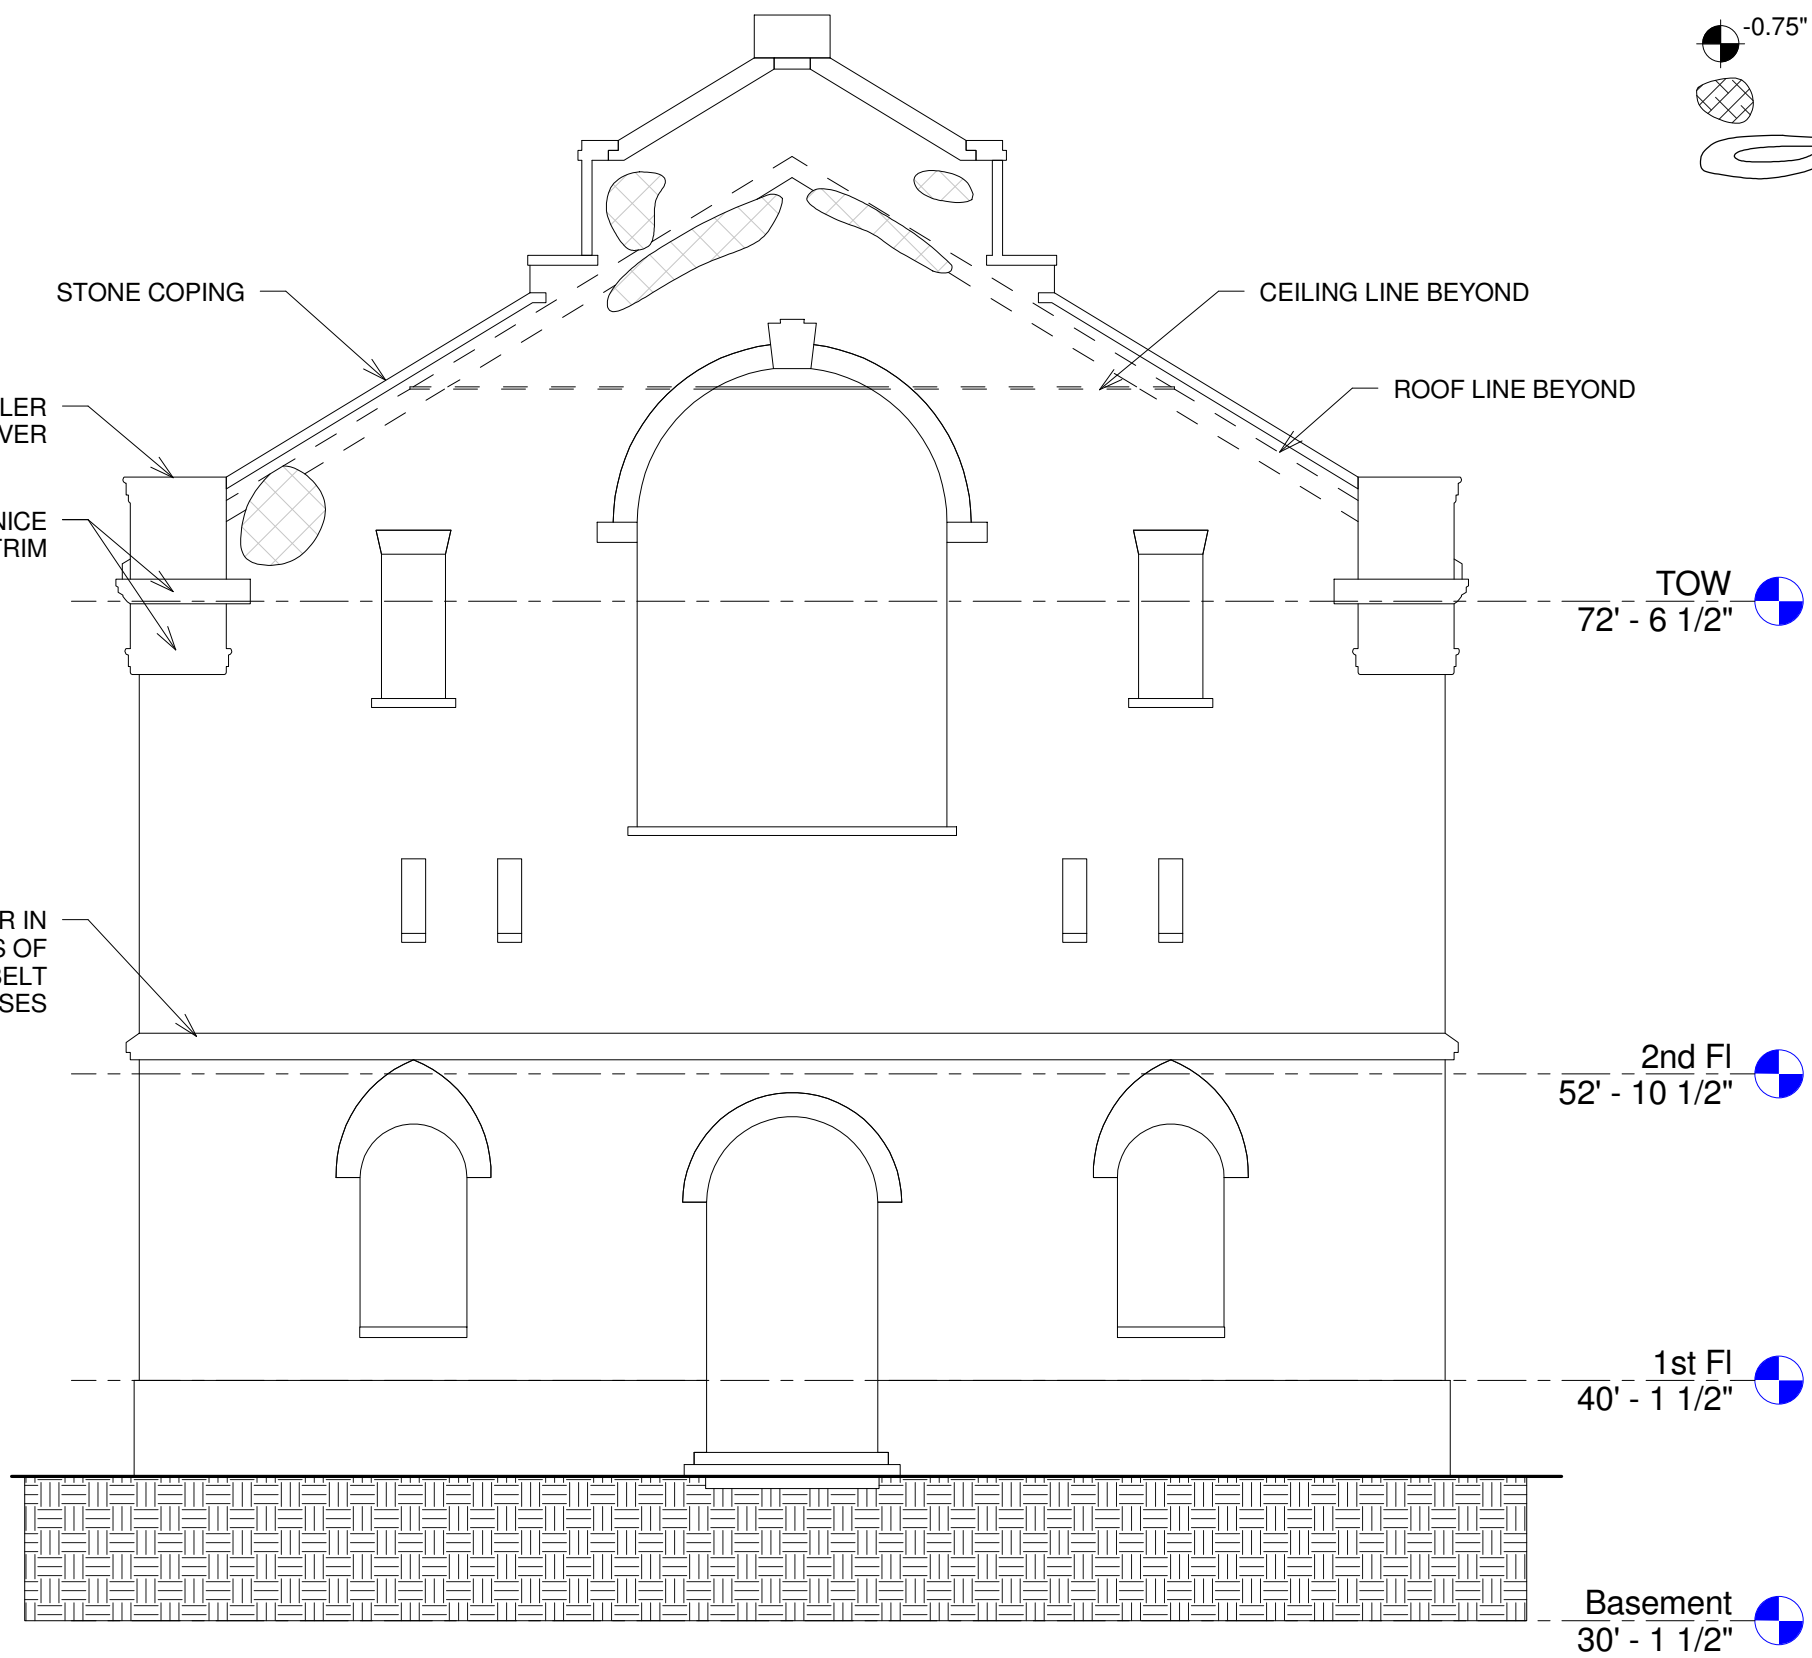
1 West Elevation
1/8" = 1'-0"

MOST DETERIORATION SEEN IN THESE END WALLS IS NEAR THE ROOF LINE WHERE BRICK CYCLES THROUGH GREATER FREQUENCIES AND RANGES OF TEMPERATURE CHANGES LEADING TO TRAPPED MOISTURE FREEZING WITHIN WALLS DURING WINTERS.
